NATIONAL ADVISORY COMMITTEE FOR AERONAUTICS

TECHNICAL NOTE 3269

ADDITIONAL STATIC AND FATIGUE TESTS OF HIGH-STRENGTH
ALUMINUM-ALLOY BOLTED JOINTS

By E. C. Hartmann, Marshall Holt, and I. D. Eaton

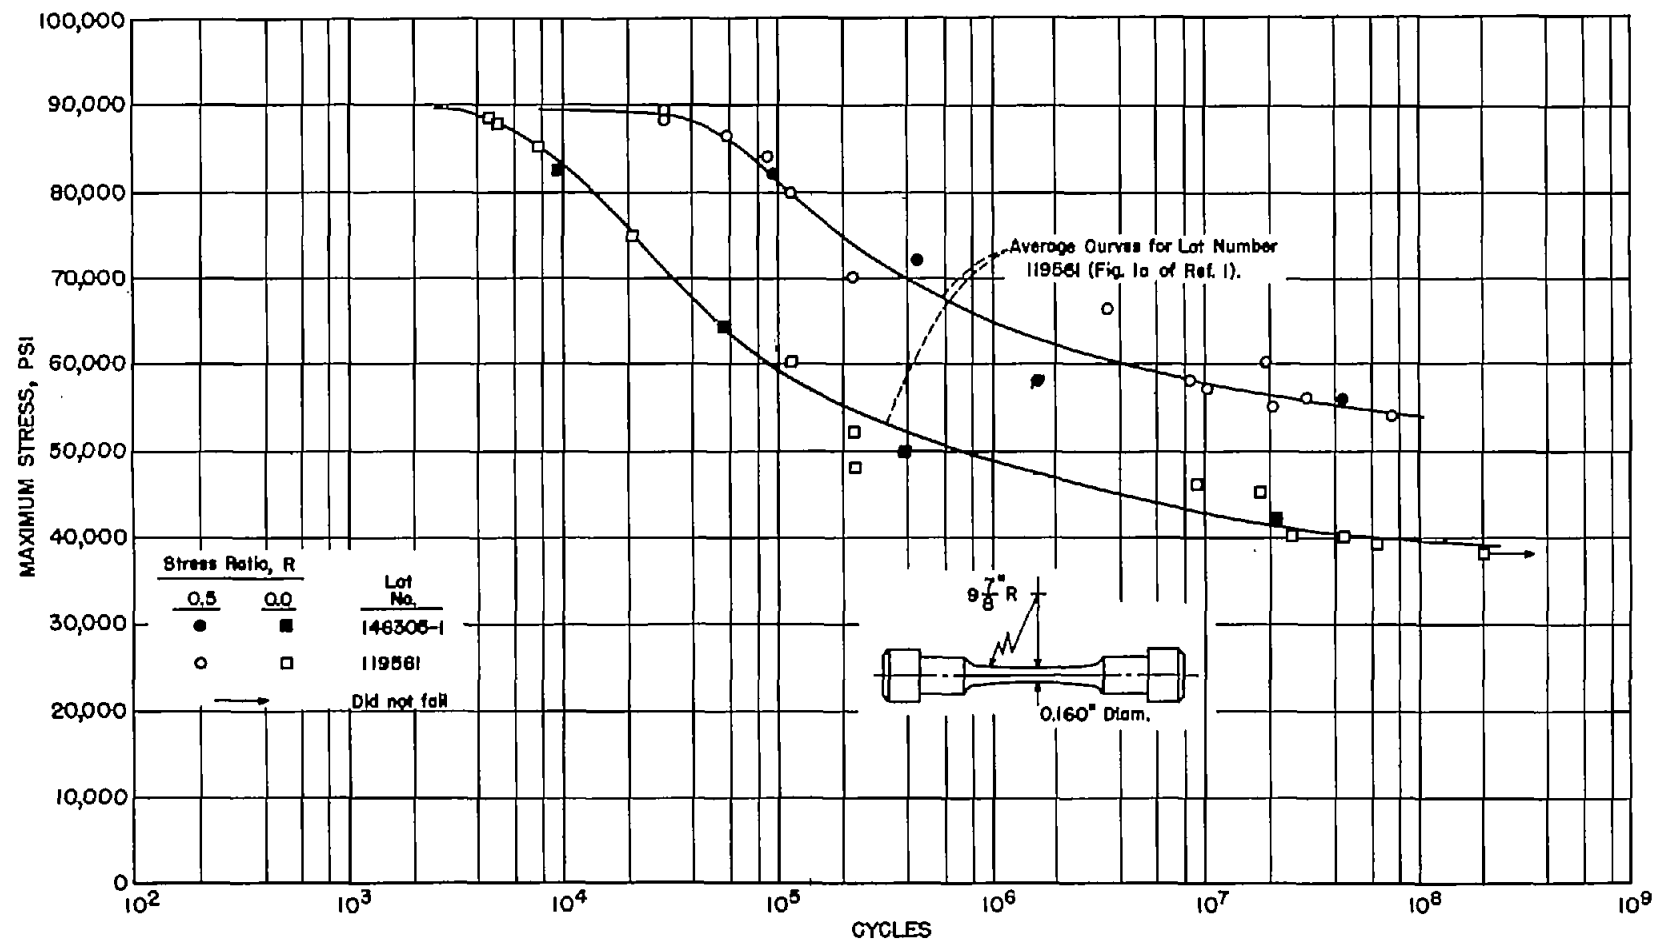
Figure 1.- Direct tension-compression fatigue data for 75S-T6 extruded bar
 (1 1/4 by 4 inches).

Direct-stress fatigue tests were made on polished round specimens as described in reference 1 to determine the degree of agreement of basic fatigue strengths for the old and new lots of 75S-T6 and 24S-T4 aluminum alloys. The fatigue test results for the two lots of each alloy are plotted in figures 1 and 2 where it is seen that the direct-stress fatigue strengths for the two lots of 75S-T6 compare very well and that the fatigue strengths of the new lot of 24S-T4 are slightly higher than the results obtained on the original lot, but such small differences are not considered significant in light of the data in reference 3.

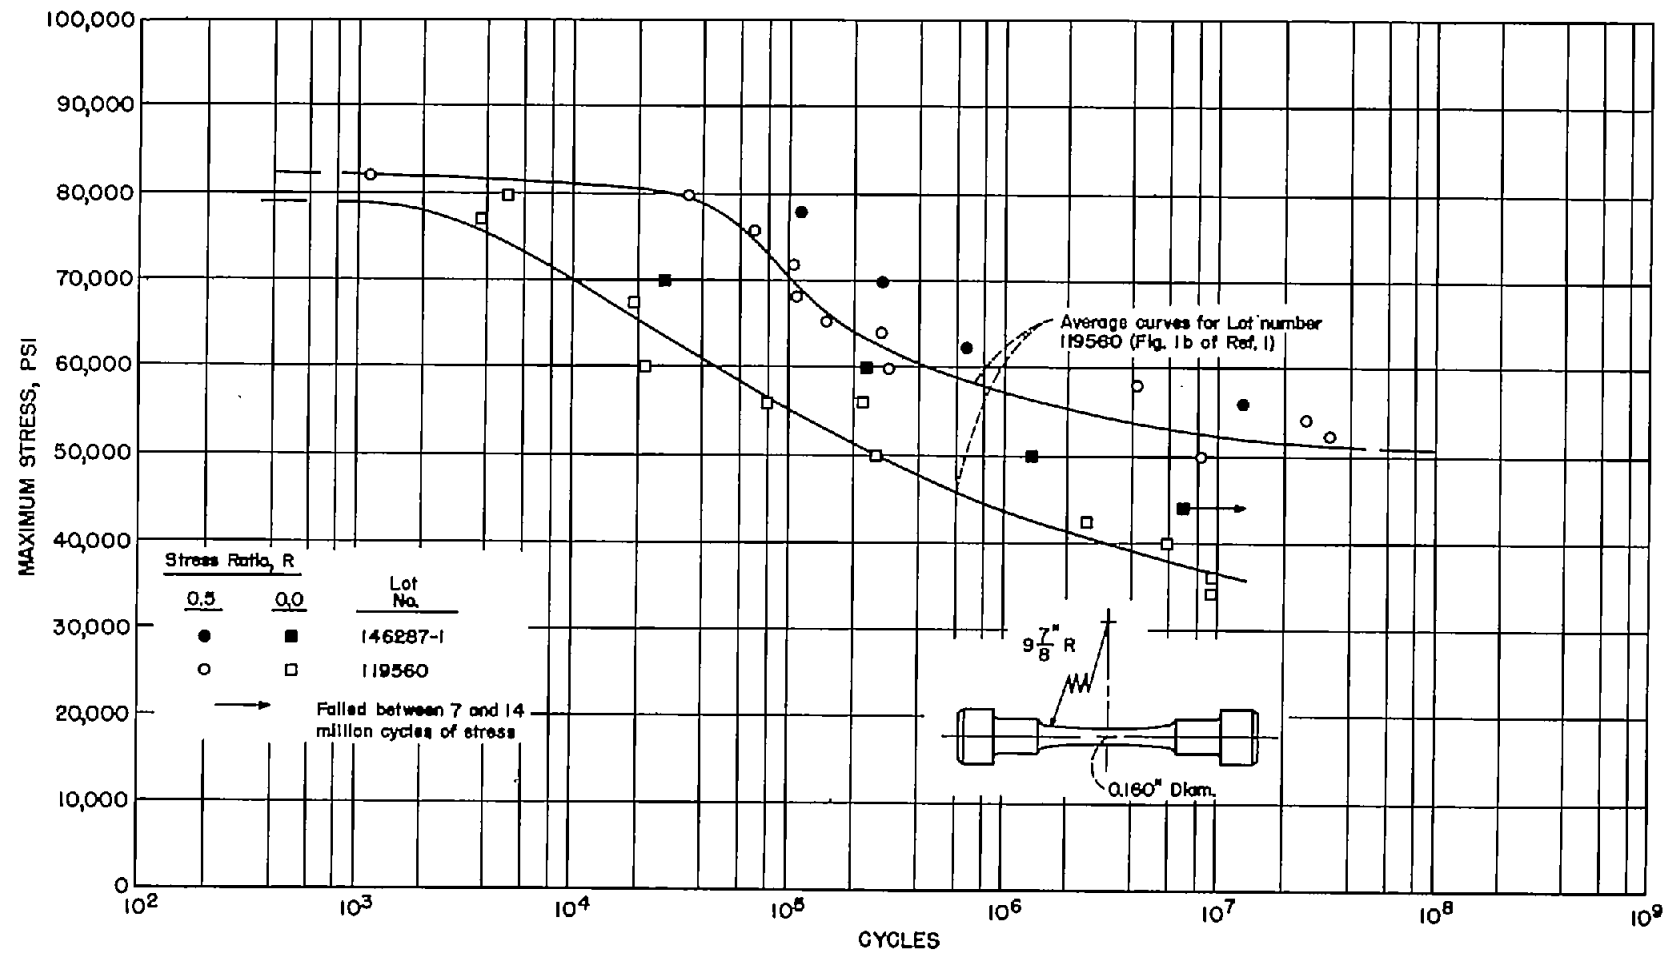
Figure 2.- Direct tension-compression fatigue data for 248-T4 extruded bar ($\frac{1\frac{1}{4}}{4}$ by 4 inches).

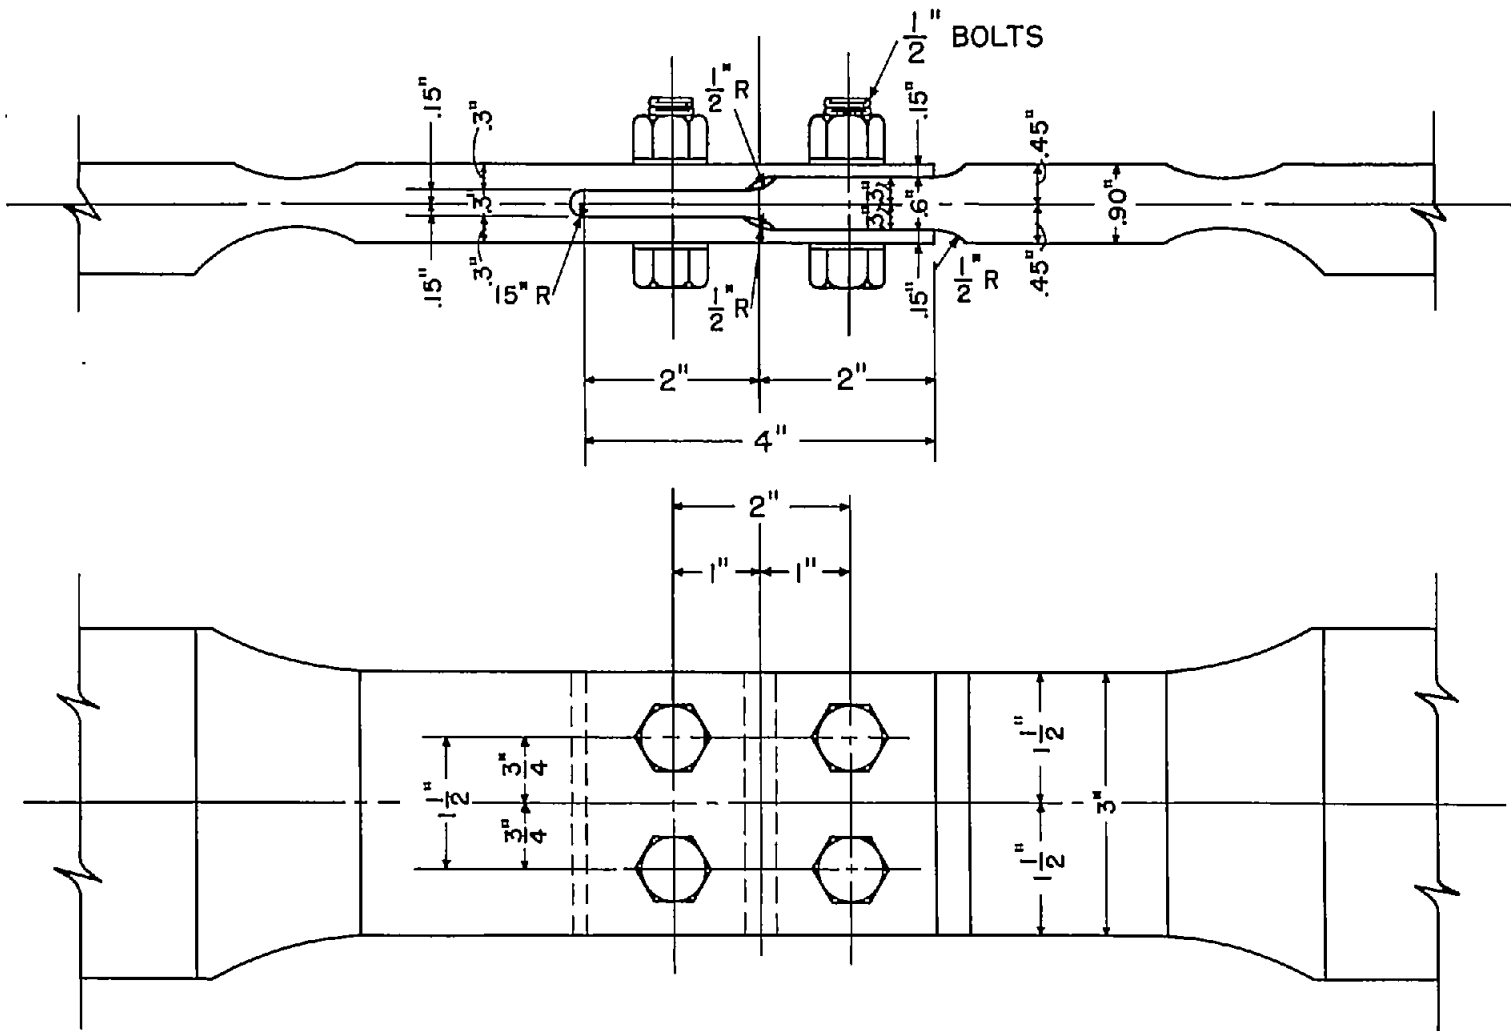
Figure 3.- Stepped double-shear joint specimen.

The stepped double-shear joint, the new joint type used in this investigation, is shown in figure 3. It can be seen that the net-section area is 1.2 square inches at the first row of bolt holes and 0.6 square inch at the second row of bolt holes. The bolt holes were reamed to 0.0010 to 0.0020 inch under the measured bolt diameter.

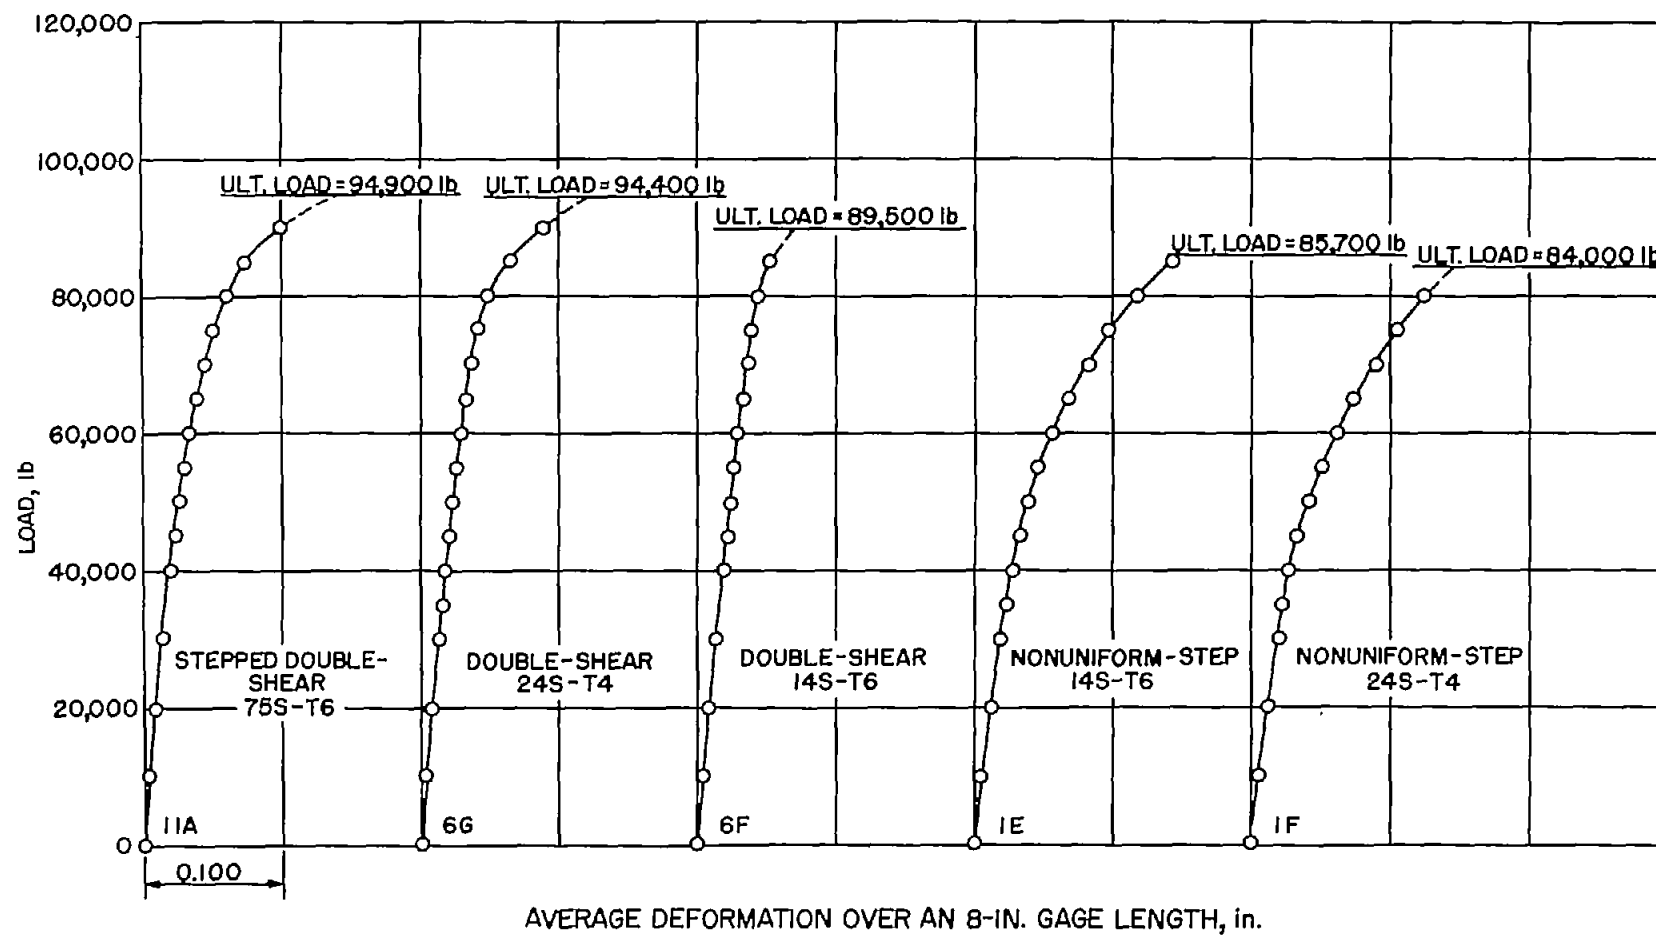
Figure 4.- Curves of static tensile load against deformation for high-strength aluminum-alloy bolted joints.

The results of the additional static tests are presented in figure 4 and are summarized in table II, together with the results for the 75S-T6 nonuniform-step and double-shear joints taken from table IV of reference 1.

The stepped double-shear joint, the new joint design tested in this investigation, withstood an ultimate load of 94,900 pounds, in other words, 29,200 pounds per pound of joint weight. The deformation in an 8-inch gage length under a load of 16,000 pounds was 0.0060 inch. When compared with the static test results of the other 75S-T6 aluminum-alloy joints given in reference 1, it is found that the ultimate load of the stepped double-shear joint is lower than that of the double-shear (115,250 pounds), the uniform-step (107,800 pounds), the plain-scarf (107,250 pounds), and the nonuniform-step (100,000 pounds) joints. The ultimate load of the new stepped double-shear joint exceeds the ultimate loads of the bolted-keyed, double-scarf, single-shear, serrated, and clamped-keyed joints. The load per pound of weight and deformation in 8 inches at 16,000-pound load are also intermediate to the values obtained for the other types of 75S-T6 joints.

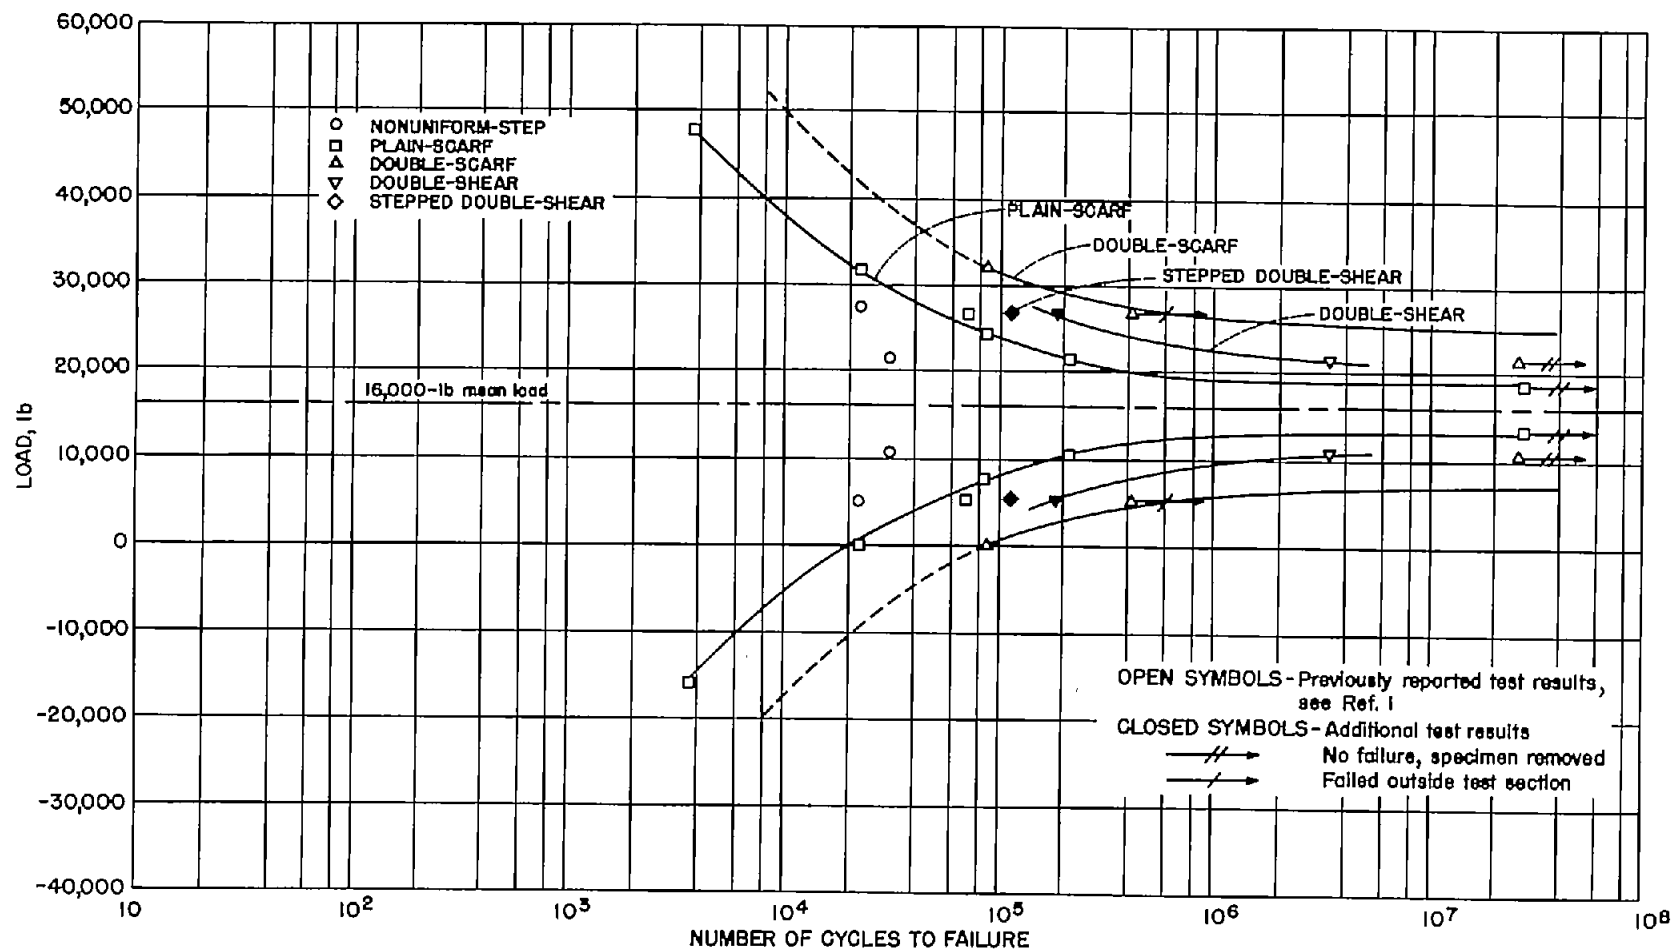
Figure 6.- Direct-stress fatigue curves for 75S-T6 aluminum-alloy bolted joints. Mean load, 16,000 pounds.

The result of the fatigue test on the stepped double-shear joint is included in table IV and is plotted with other results from this and the initial part of the investigation in figure 6. It can be seen that, of the 75S-T6 joints tested, the fatigue life of the stepped double-shear joint (111,400 cycles) is exceeded by that of the double-scarf (418,000 cycles) and double-shear (187,400 cycles) joints. The fatigue fracture shown in figure 7 occurred at the bolt holes in the thin portion of the tongue. No additional fractures were found, either in the tongue or in the outside members.

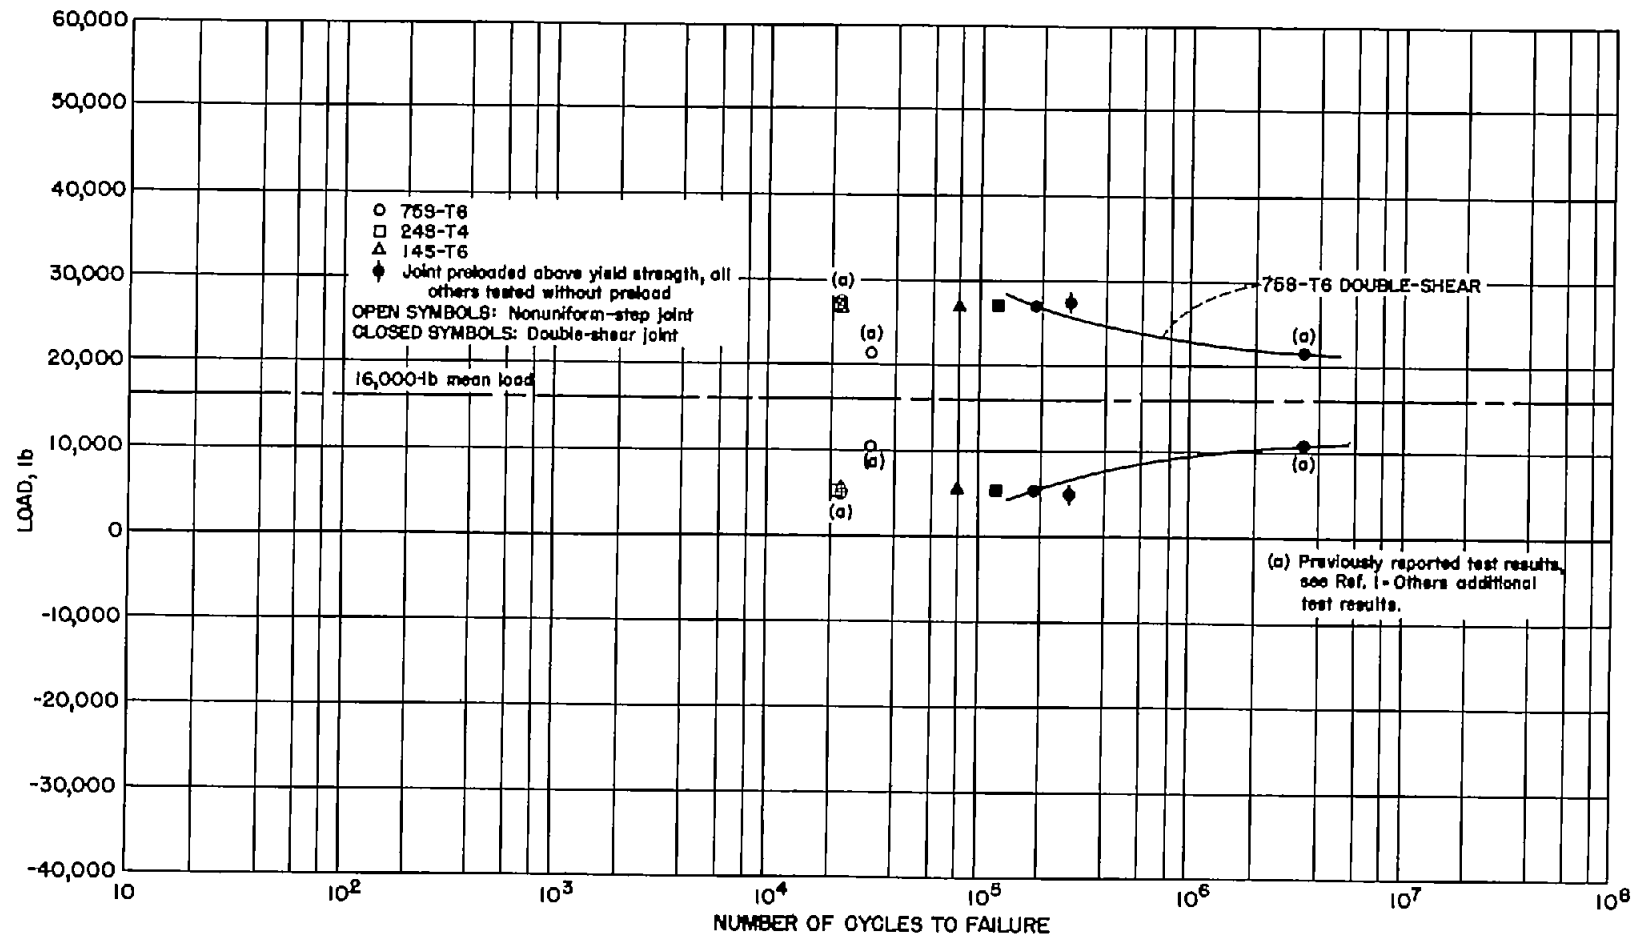
Figure 8.- Direct-stress fatigue curves for double-shear and nonuniform-step joints of 75S-T6, 24S-T4, and 14S-T6 aluminum alloys. Mean load, 16,000 pounds.

Direct-stress fatigue test results for the double-shear and nonuniform-step joints of the three aluminum alloys under consideration are plotted in figure 8 and are included in the summary of table V. For the conditions of 16,000-pound mean load $\pm 10,670$ pounds, it can be seen that there is no significant difference in the fatigue lives of the nonuniform-step joint in any of the three alloys studied. At a load of 16,000 pounds $\pm 10,670$ pounds, the fatigue life of the 75S-T6 double-shear joint exceeds the fatigue lives of the 24S-T4 and 14S-T6 double-shear joints by ratios of 1.5:1 and 2.3:1, respectively.

The direct-stress fatigue test results for the plain-scarf and double-shear aluminum-alloy joints, which had been preloaded with a static load, have been plotted in figures 8 and 11 and are included in the summary in table VI. It can be seen that the ratio of the fatigue life of the plain-scarf joint with preload to that of plain-scarf joint without preload is 5.9:1. The preloaded plain-scarf joint failed through the first row of bolt holes similar to the failure of the plain-scarf joint without preload shown in figure 15(b) (joint 2) of reference 1. The like ratio for the double-shear joints was found to be 1.4:1. As shown in figure 15, the preloaded double-shear joint failed in one of

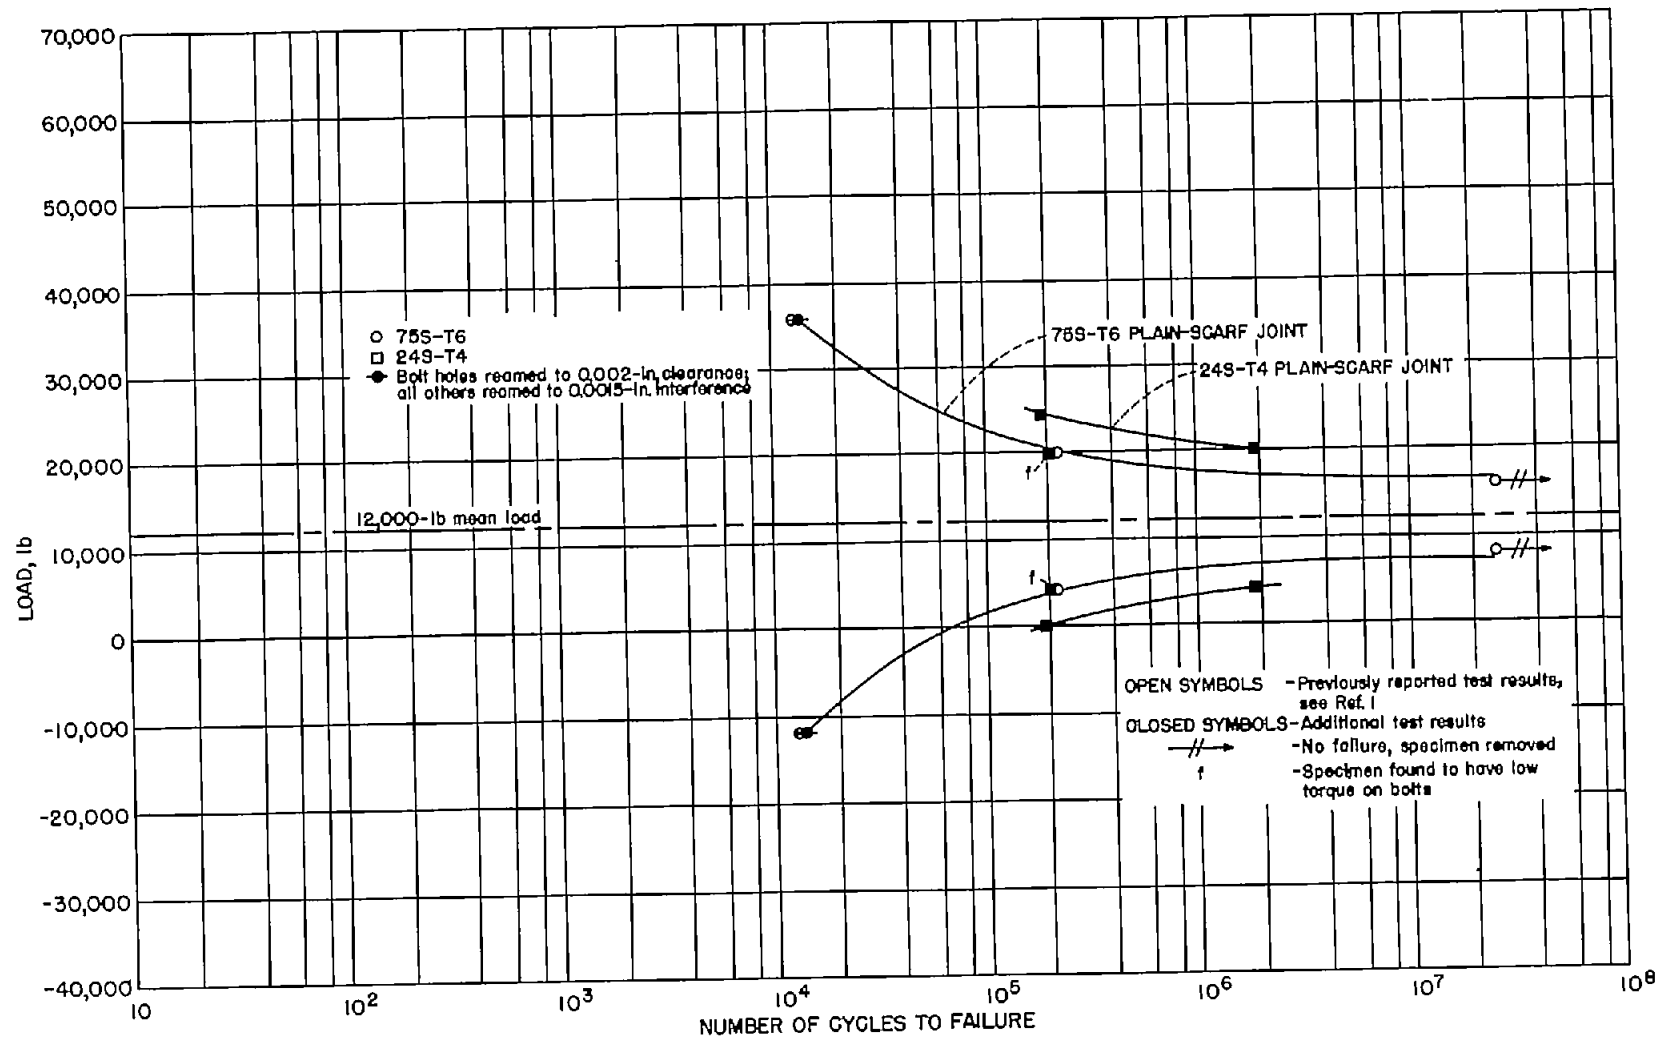
Figure 9.- Direct-stress fatigue curves for plain-scarf joints of 75S-T6 and 24S-T4 aluminum alloy. Mean load, 12,000 pounds.

The summary of results of direct-stress fatigue tests for the plain-scarf joints of 75S-T6, 24S-T4, and 14S-T6 at a mean load of 16,000 pounds and various variable loads, given in table X of reference 1, is extended in table V and figure 9 to include similar comparisons of 75S-T6 and 24S-T4 plain-scarf joints tested with a 12,000-pound mean load and various variable loads. It can be seen that the 24S-T4 plain-scarf joint gives consistently greater fatigue life than the 75S-T6 joint with the ratios of fatigue lives ranging from 1.4:1 to 18.5:1 for the mean loads and stress ratios used in these tests. For like stress ratios the fatigue-life ratios are larger in favor of 24S-T4 at the 12,000-pound mean load than at the 16,000-pound mean load.

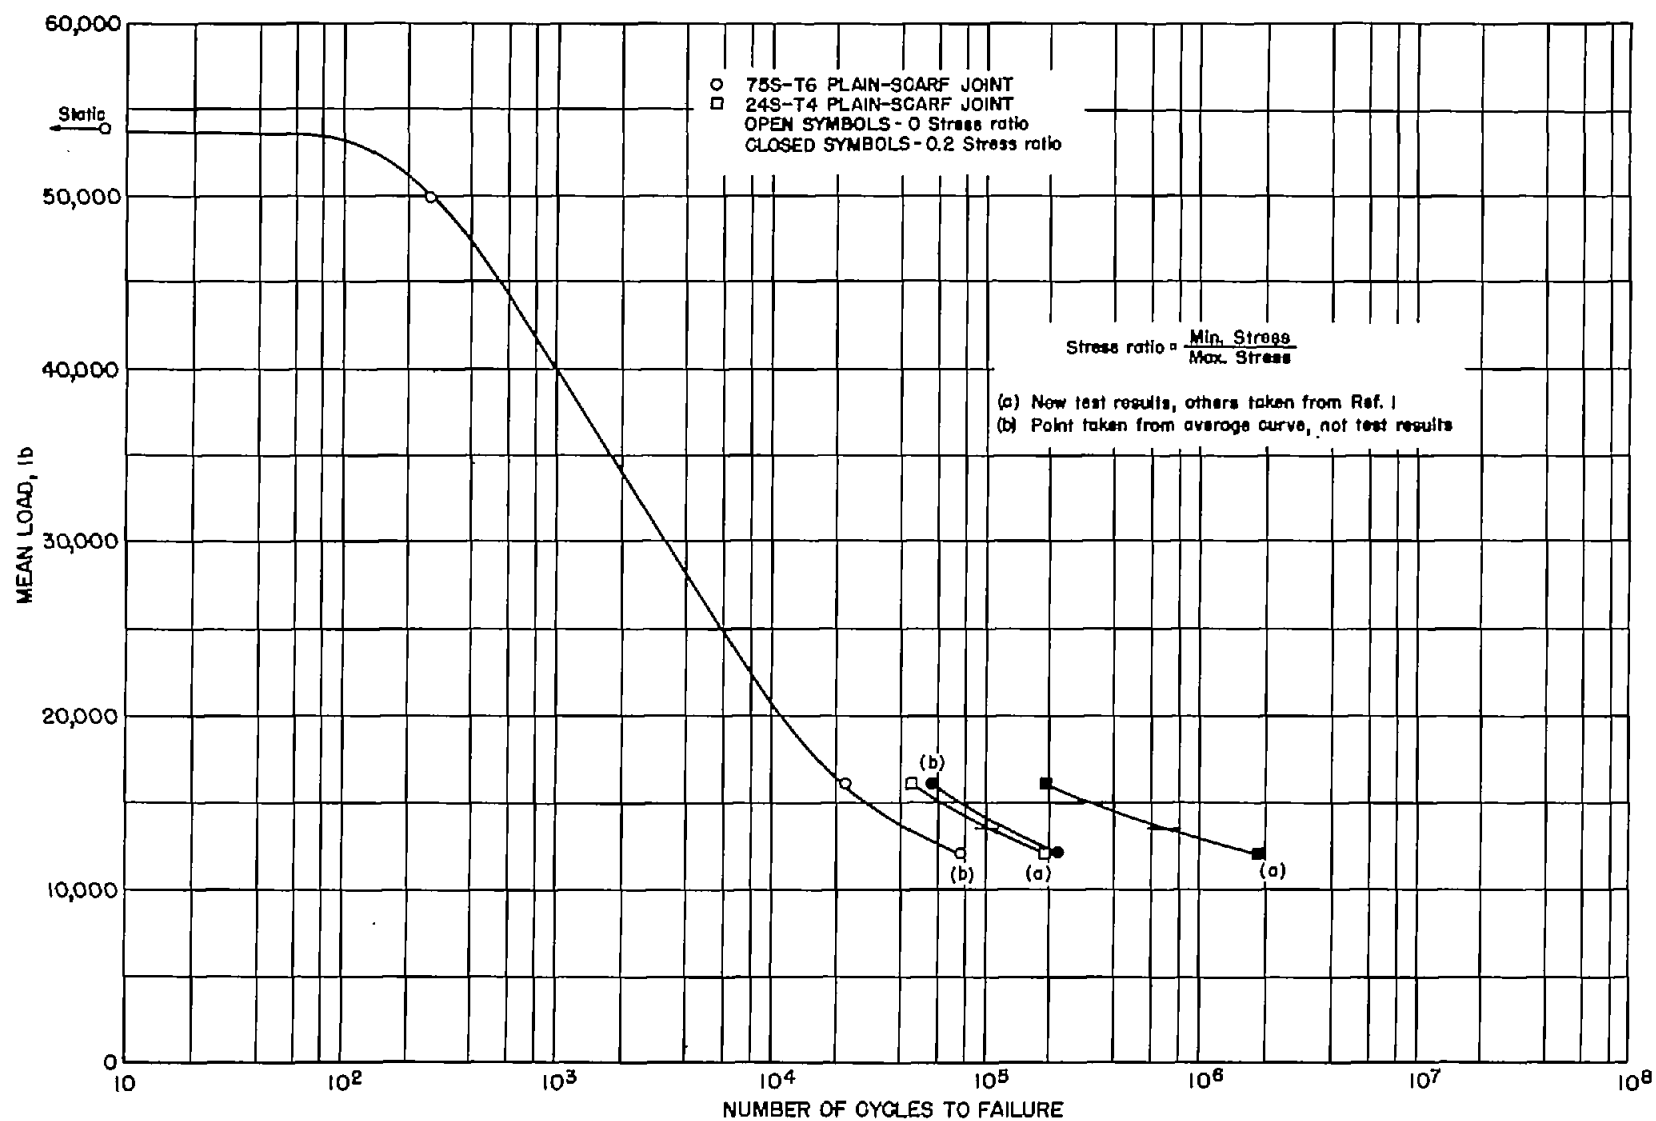
Figure 10.- Direct-stress fatigue curves for plain-scarf joints of 75S-T6 and 24S-T4 aluminum alloy. Mean load versus number of cycles to failure.

The direct-stress fatigue test results for the 75S-T6 and 24S-T4 aluminum-alloy plain-scarf joints at 0 and 0.2 stress ratios have been replotted in figure 10. In order to take care of differences in the static properties of the 75S-T6 and 24S-T4, the fatigue results for the 75S-T6 and 24S-T4 joints should be compared at lower loading conditions for the 24S-T4 joint than for the 75S-T6 joint, that is, on the basis of mean loads of 13,600 pounds and 16,000 pounds, respectively, which are proportional to the ultimate static strengths of the joints. Thus it can be seen in figure 10 that at a mean load of 13,600 pounds the 24S-T4 plain-scarf joint would be expected to fail at 100,000 and 680,000 cycles for the 0 and 0.2 stress ratios, respectively. Included in table V are comparisons of these results with the results for the 75S-T6 plain-scarf joints at the higher mean load of 16,000 pounds and at like stress ratios. The ratio of fatigue lives for the 24S-T4 joint to that of the 75S-T6 joint, when the load on the 24S-T4 joint is adjusted to take account of differences in the static strengths of the joints, is 4.6:1 and 12.4:1 for the 0 and 0.2 stress ratios, respectively. Had the loading on the 24S-T4 joint been adjusted on the basis of the ratio of the ultimate tensile strengths of the materials the mean load would be 14,600 pounds and the ratios of the fatigue life of the 24S-T4 joint to the fatigue life of the 75S-T6 joint would have been 3.2:1 and 6.7:1 for stress ratios of 0 and 0.2, respectively. Further, had the adjustment been made on the basis of the applicable guaranteed minimum values given in reference 2, the adjusted load on the 24S-T4 would have been 13,000 pounds and ratios of fatigue lives of the 24S-T4 to the 75S-T6 joints would have been 6.0:1 and 16.6:1. On the other

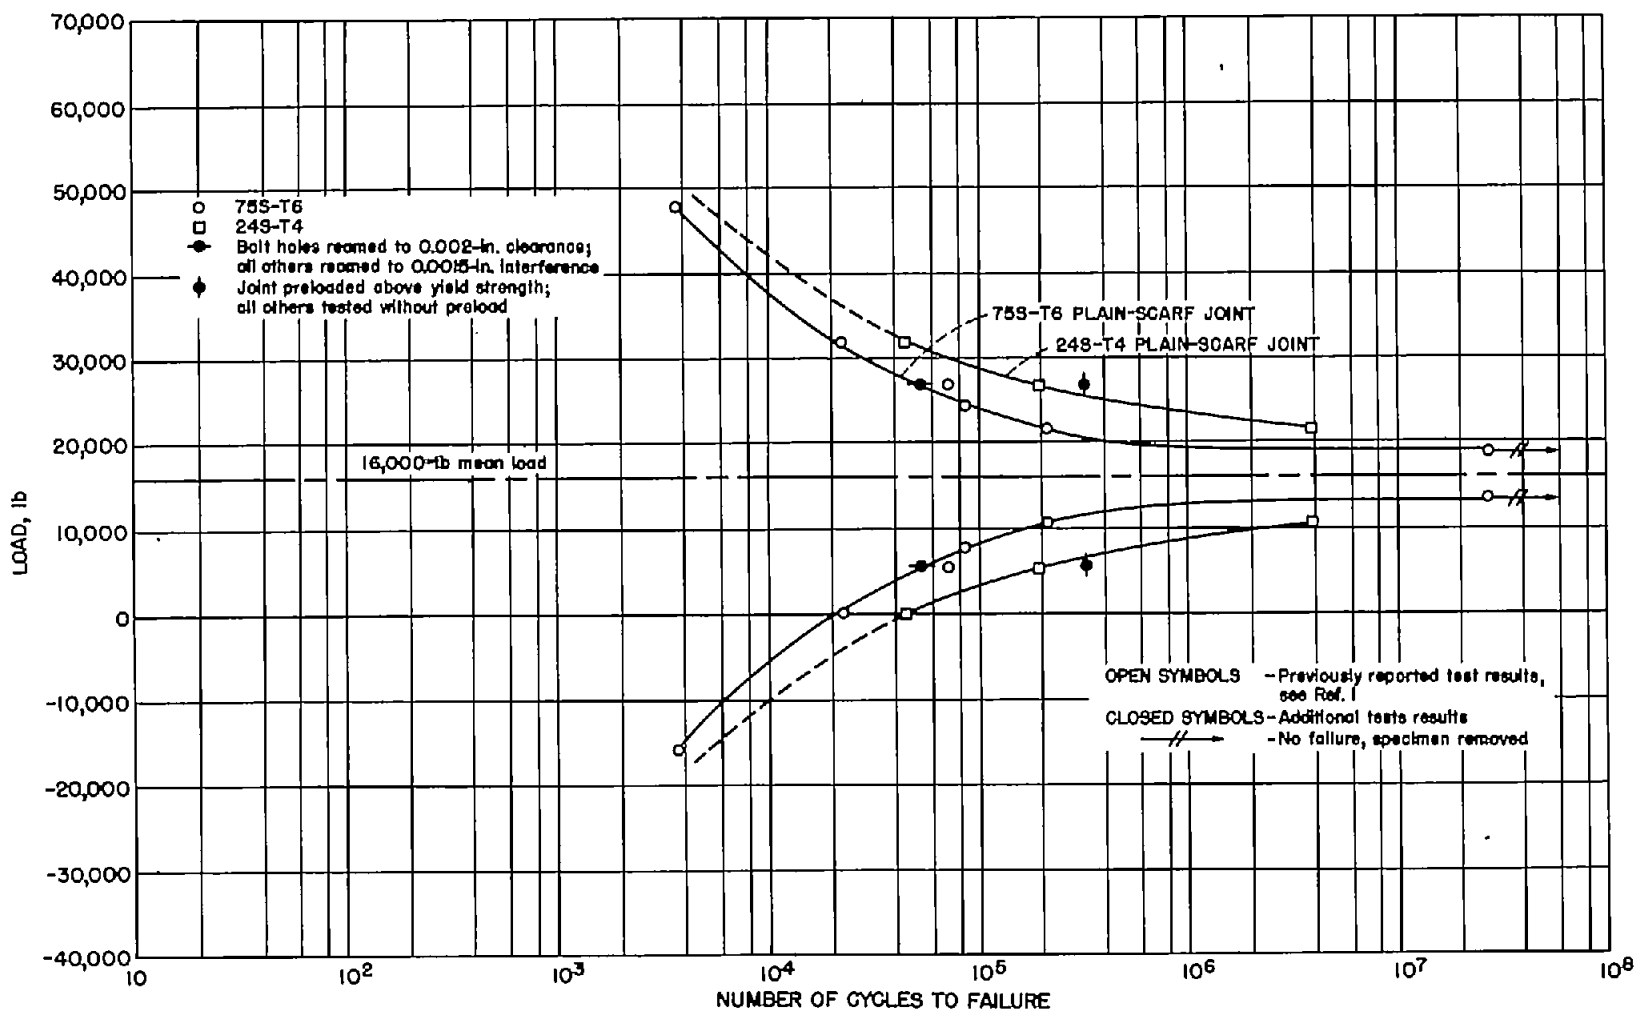
Figure 11.- Direct-stress fatigue curves for plain-scarf joints of 75S-T6 and 24S-T4 aluminum alloy. Mean load, 16,000 pounds.

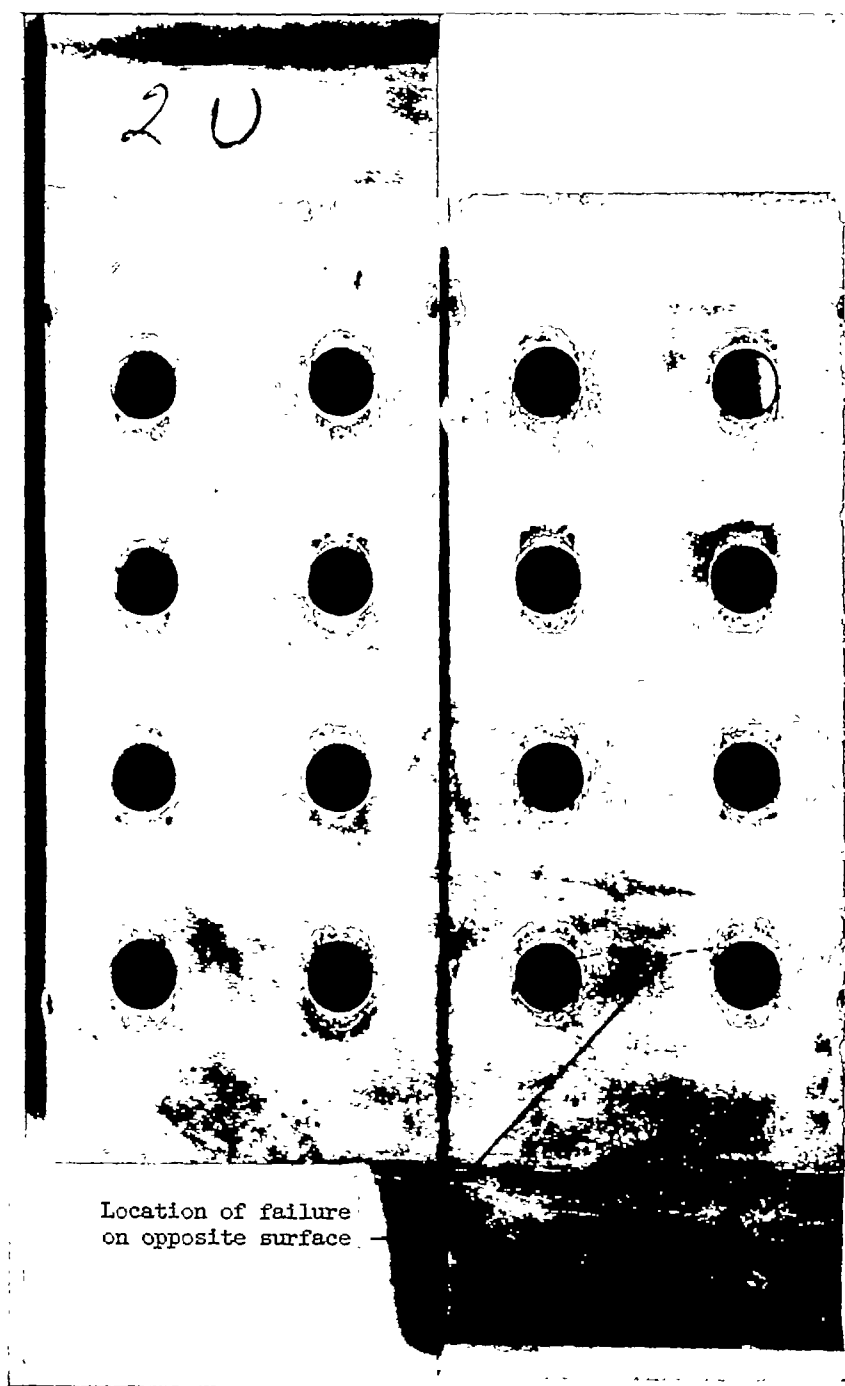
Figure 13.- Plastic deformation at bolt holes of faying surfaces of plain-scarf joint which had been loaded to high static loading previous to fatigue test. Photographed after fatigue test. (For views of failure on opposite surface see fig. 14.)

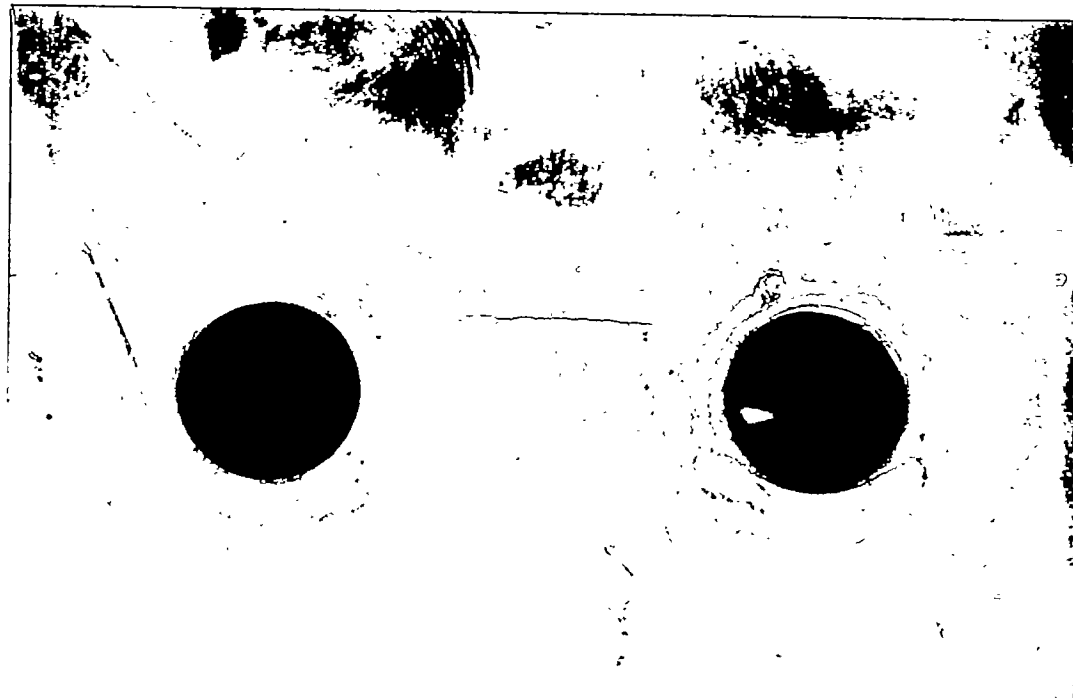
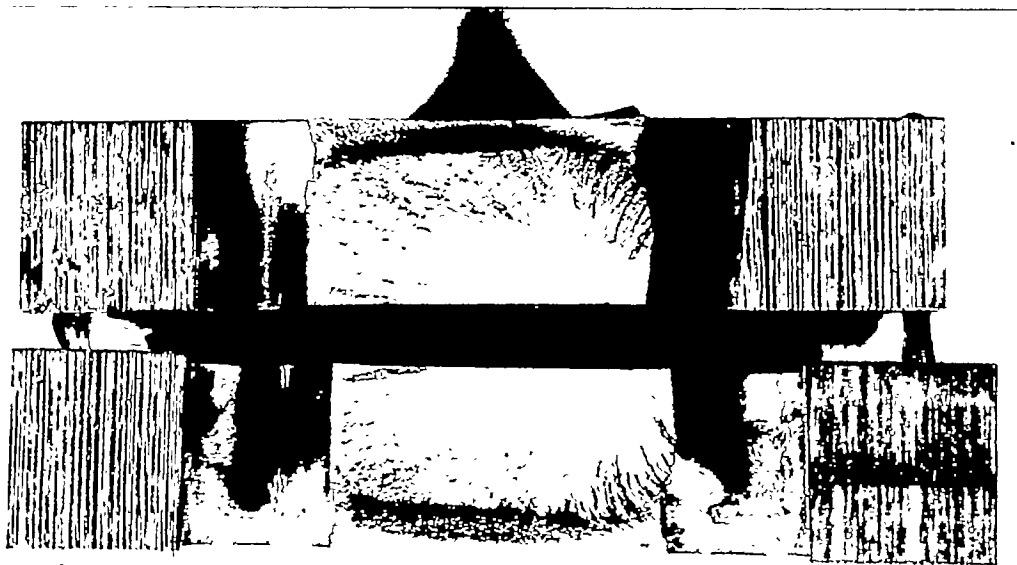
L-83694
Figure 14.- Fatigue failure of plain-scarf joint which has been loaded to high static loading previous to fatigue test. (For location of bolt holes see fig. 13.)

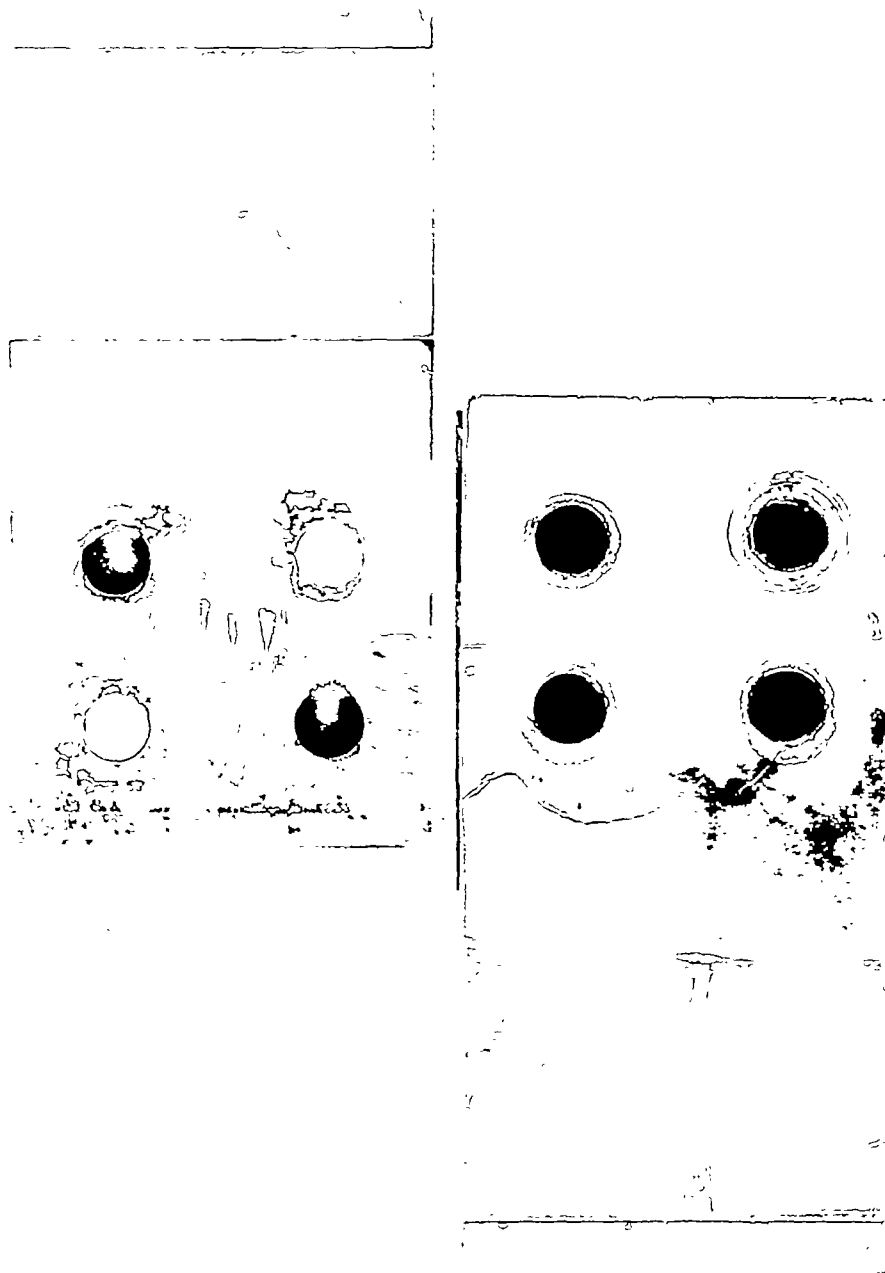
L-83695
Figure 15.- Fatigue failure in double-shear joint which had been loaded to high static loading previous to fatigue test.

the outside members in a pattern quite unlike that of the corresponding joint without preload shown in figure 15(b) (joint 9B) of reference 1. Figure 16 shows the fractured surface of the preloaded specimen. Metallographic examination indicated that the fracture originated in a fretted area on the faying surface. No sign of additional fractures was evident in the tongue of this specimen. Unless the galling caused some reduction in life of this specimen, it would appear that the location of the critical section in the double-shear joint was changed by the preload imposed with little gain in fatigue life of the joint. It has been said that preloading to 67 percent of ultimate strength increases the fatigue life from two to tenfold. The result of the test on the preloaded plain-scarf joint is in agreement with such a statement. The National Bureau of Standards has reported results of fatigue tests on sheet with static preload (ref. 4) which show beneficial as well as detrimental effects of preloading on fatigue life. It would appear from the two tests made on bolted joints that preloading may or may not have significant beneficial effects on the fatigue life of a joint.

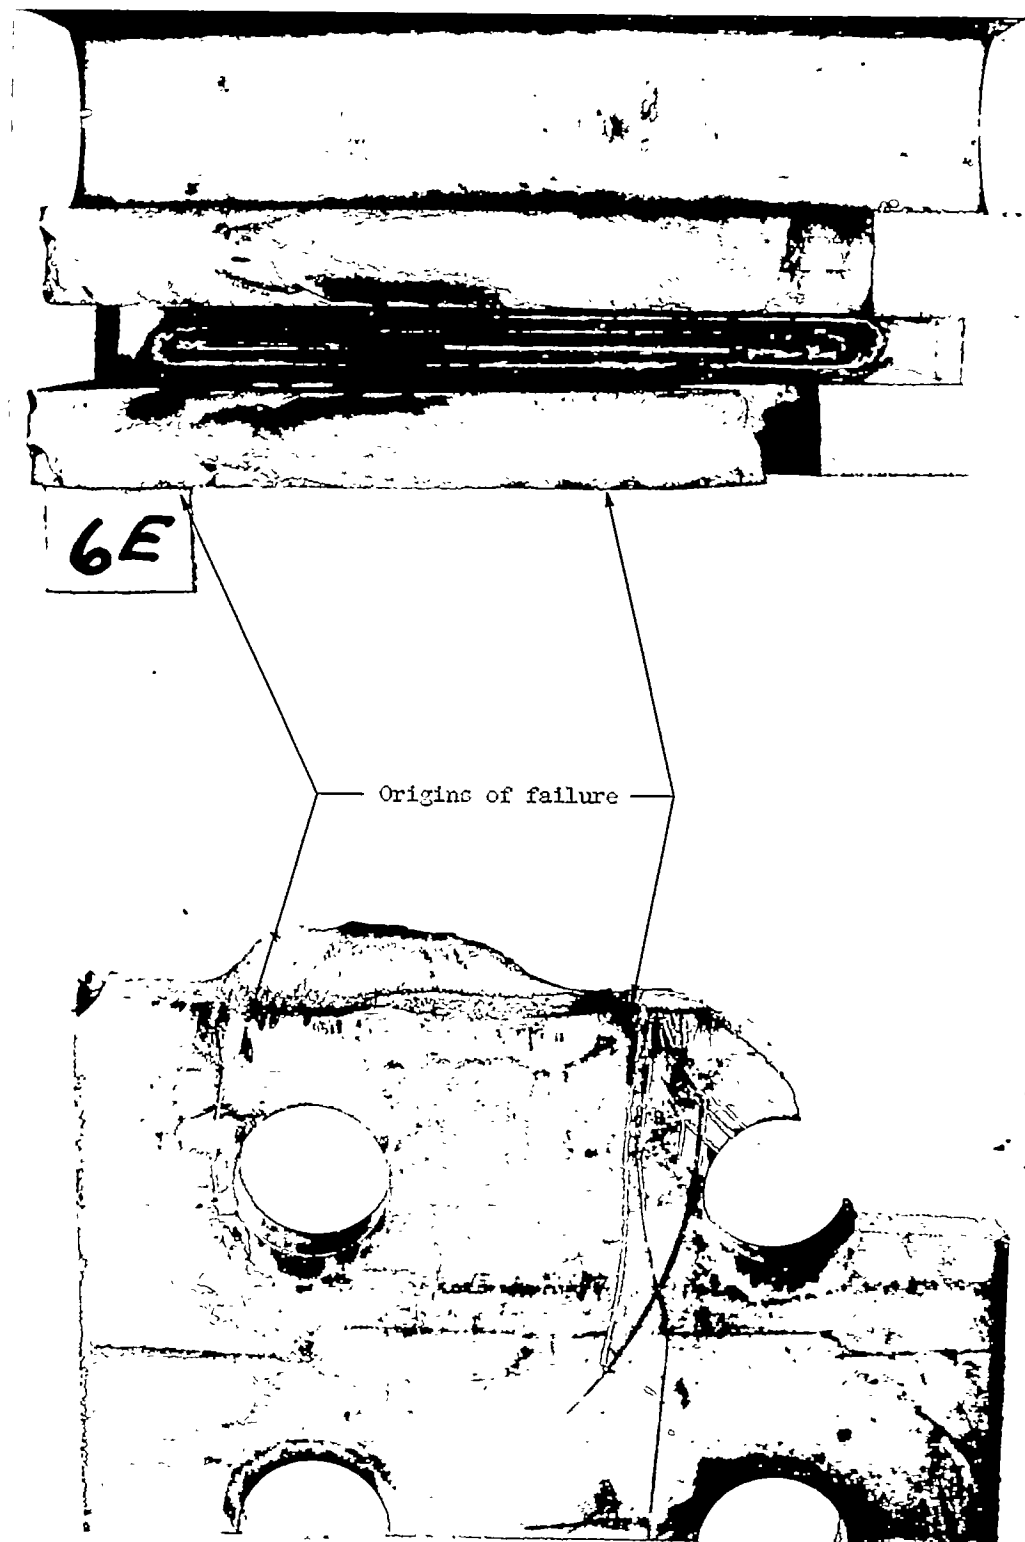
Figure 16.- Failure of double-shear joint which had been loaded to high static loading previous to fatigue test. L-83696
